AIRCRAFT ACCIDENT REPORT

IMPERIAL AIRLINES, INC., LOCKHEED CONSTELLATION L-049,
N 2737A, BYRD FIELD, RICHMOND, VIRGINIA,
NOVEMBER 8, 1961

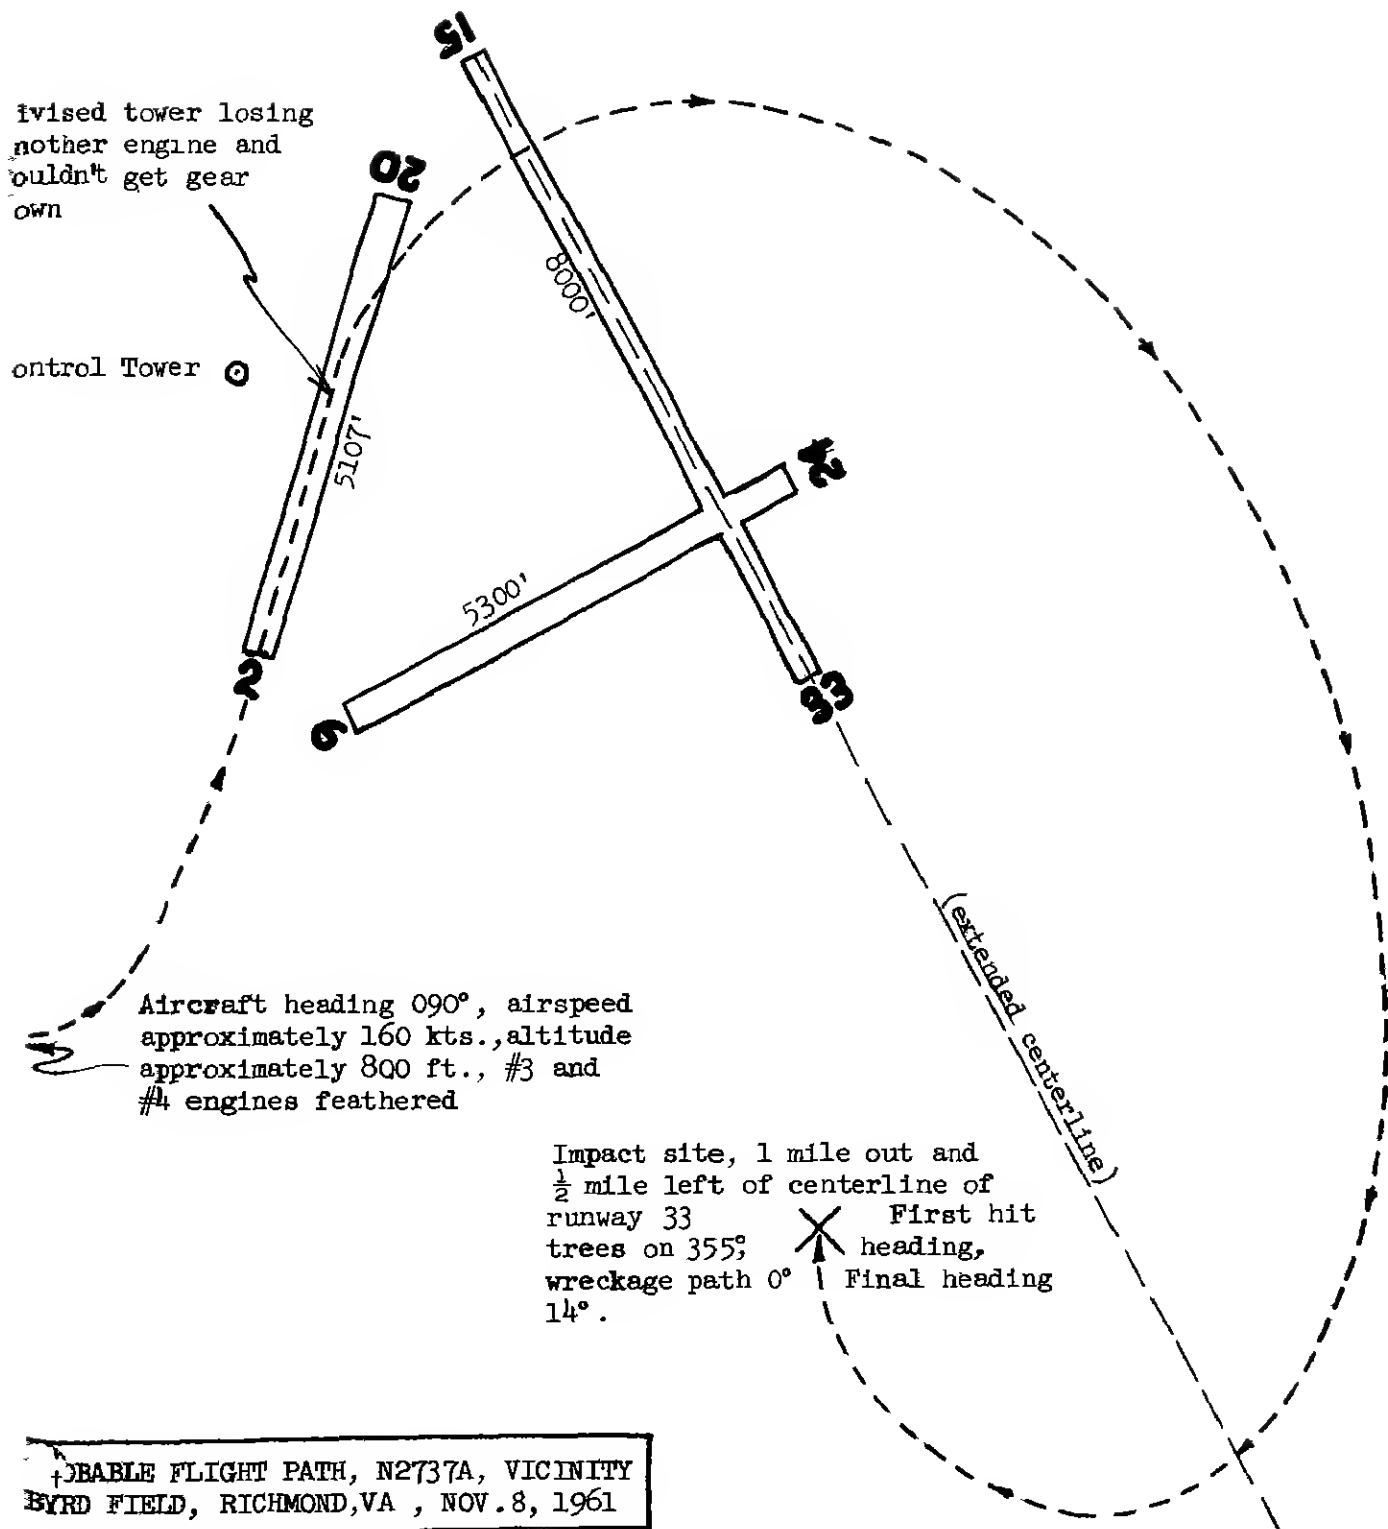
DEABLE FLIGHT PATH, N2737A, VICINITY
BYRD FIELD, RICHMOND, VA , NOV. 8, 1961

From the location of the wreckage it is apparent that the landing pattern was poorly executed. It is believed that when the airplane was on its base leg the bank angle was steepened in an attempt to avoid overshooting the extended centerline of the runway. This increased angle of bank and increased rate of turn bled off airspeed and the aircraft began to sink. To try to arrest the sink rate Greenlee called for "...all the power you got." By this time the No. 1 engine was destroying itself as a result of the over boosting during the emergency. It failed completely. With only one engine delivering power it was impossible to maintain flight and the aircraft stalled into the trees.
